# THE MIDDLESEX CANAL RESTORATION Program Study

Winchester • Woburn • Wilmington • Billerica • Chelmsford • Lowell  
Massachusetts

*prepared for*  
The Middlesex Canal Commission

*prepared by*  
**The Waterfield Design Group, Inc.**  
50 Cross Street    Winchester    Massachusetts    01890    USA

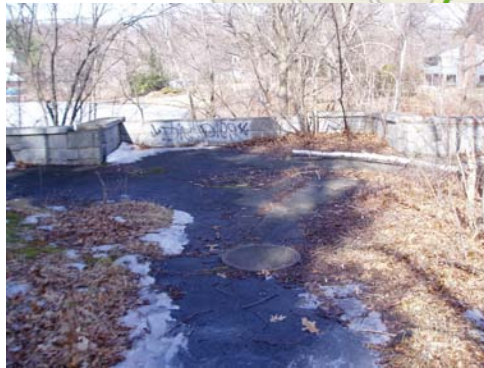
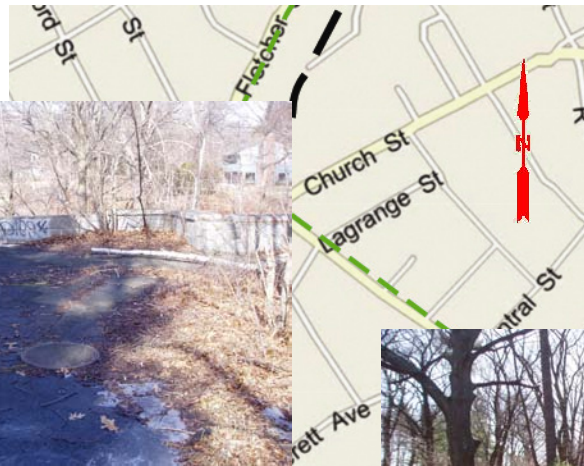
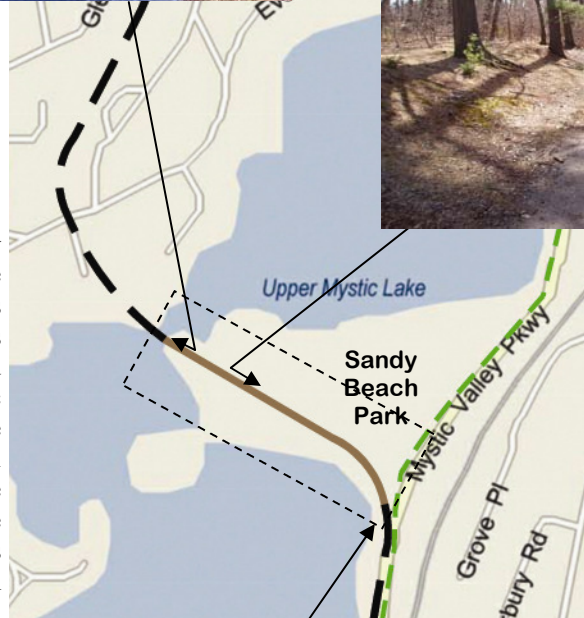
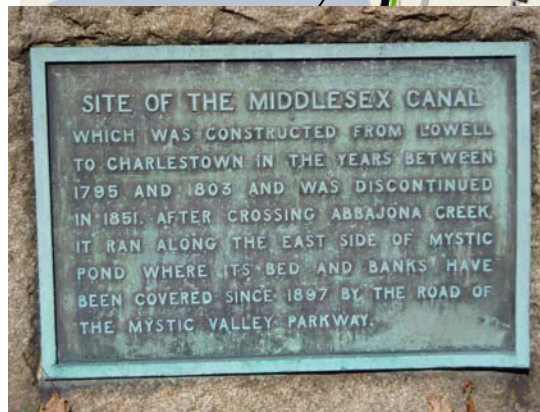
This segment of the canal is visible from the Mystic Valley Parkway. A stone marker has been placed at the entrance to the site describing the past presence of the canal. At this point the beginnings of a recognizable cross section turns in from the sidewalk along the Mystic Valley Parkway and continues along Sandy Beach Park on toward the Mystic Lake. The canal bed is dry and the bottom is paved for use as an access way by the DCR. Midway along the canal segment is the remains of a holding pond which was once used by canal boats waiting to cross an aqueduct over the Mystic Lakes. Currently the DCR keeps a dumpster at this location. Several sewer manholes were witnessed within the canal bed. Research at Town offices indicated that a sewer line runs beneath the canal toward the lake where a siphon structure is used to cross beneath the water. The sides of the canal still have some form, but are overgrown with trees and other vegetation. The overgrown condition continues into the towpath, which is located on the east side of the canal. Reaching the end of the segment there exists the remains of the old aqueduct abutment. It appears that a restoration effort had taken place at one time which may not have paid close attention to historical accuracy.

It is recommended that the canal prism be fully restored. The original cross section of the canal can be recreated without significant disruption to the current use. In addition, the area of the old holding pond provides a place in which some type of interpretive play feature could be included. An example would be a climbing structure designed to look like a canal boat. Crafted to be "play friendly", a skeletal type climbing structure would serve both enjoyment of younger visitors as well as provide a glimpse into the past when boats were held up at this location waiting to cross the nearby aqueduct.

It is also recommended that the aqueduct abutment be resorted with historical accuracy.

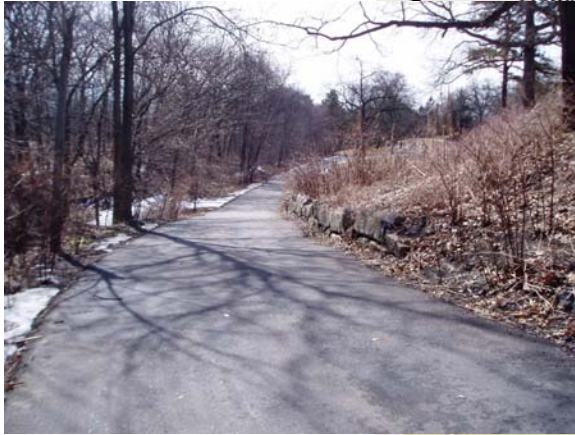
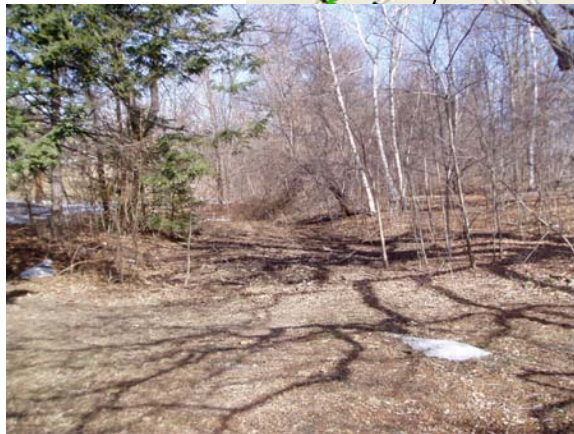
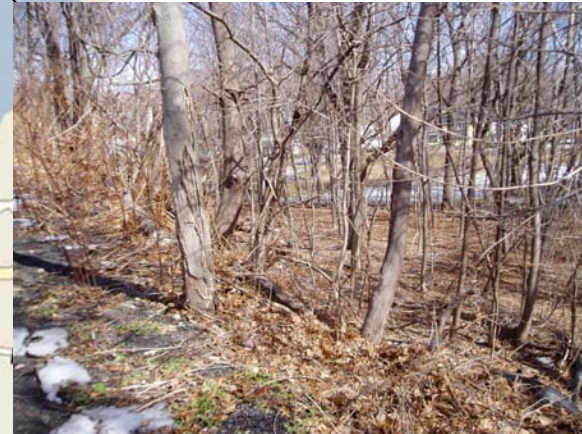
The segment begins on cemetery property at the entrance off of Palmer Street closest to Middlesex Street. The canal is difficult to locate because it has been either completely eroded or built over. According to historic documents it follows parallel with the paved cemetery road around the bend to where the houses on Middlesex Street begin. There is very little evidence of the canal's existence at this location. Definable features of the canal were not witnessed during visits to the site.

If this segment were restored, it is recommended that the canal cross section be recreated to its original condition. Signage should also be provided at various locations highlighting the canal remains.

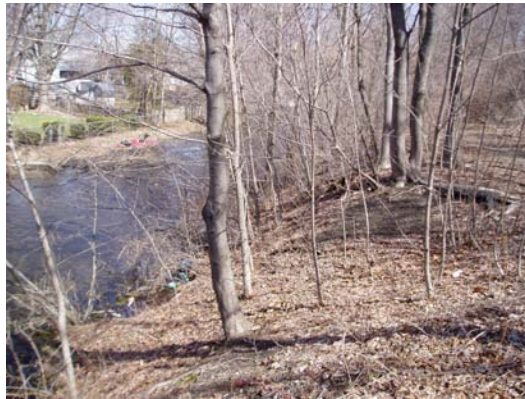
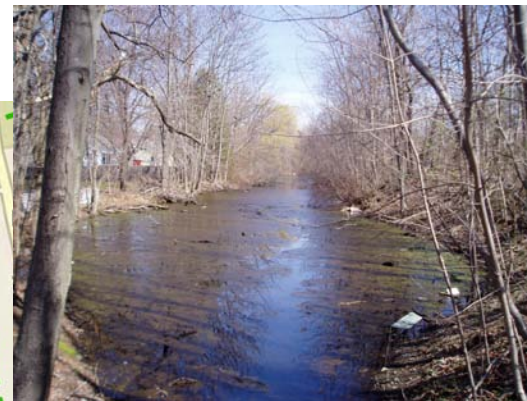
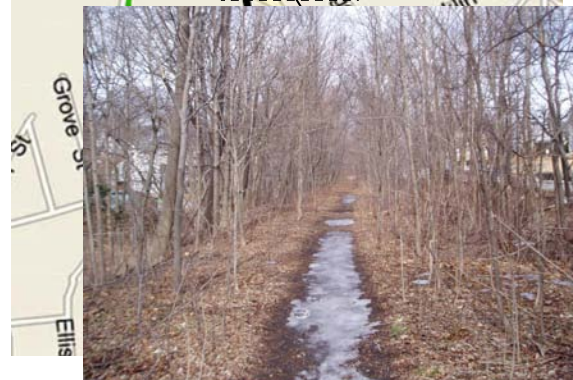
The segment is split into two halves due to Kilby Street and development over portions of the canal prism. From the south, the segment begins at Winn Street and heads north for approximately 1000 feet toward Kilby Street. There is a clear, wide path down the middle of this section with some excessive tree growth along the sides. It is believed the current path is in the center of the canal bed which appears to have been filled in for the construction of a railroad (RR) bed. Approximately 400 feet south of Kilby, the canal's original route turned to the east, outside of the current RR right-of way (ROW). It then crossed over Kilby St. and shifted back west onto the RR ROW approximately 500' north. Currently where the RR ROW meets Kilby Street, there is a large elevation gap from the RR bed to the roadway. Beyond Kilby, the canal remnants pick up again just north the apartment complex parking lot. From there, the canal continues to Lowell Street. This section of the canal holds water and the banks and towpath are overgrown while the adjacent railroad right-of-way path remains clear. Two culverts were observed, one contributing to the canal from Hart Street and the other from Lowell Street.

It is recommended that the canal prism south of Kilby Street be fully restored. North of Kilby, it is recommended that the canal sides and towpath be restored. To provide a continuous path, the RR ROW between these sections should be filled and graded to provide a pathway which can cross Kilby St. at grade.

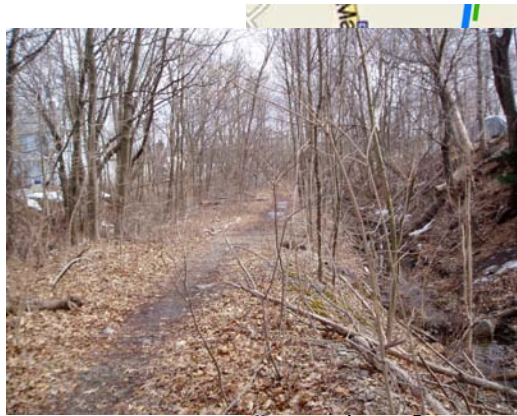
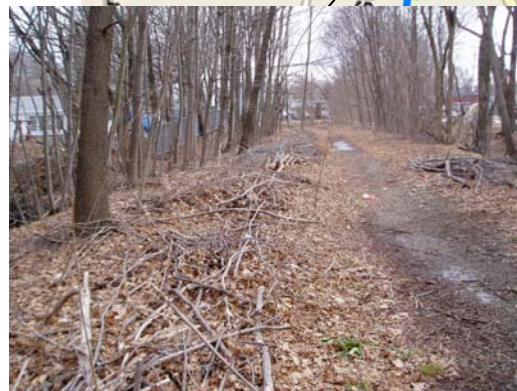
From the northern terminus at Middlesex Park, an existing path is visible down the east side of the canal. Debris was observed in the water such as tires and pieces of furniture. There were also fallen trees in the canal and on the path. Significant overgrowth has occurred with the majority concentrated on the canal sides. Two culverts were observed contributing to the waterway, one coming from Hart Street and the other from private property on the east side.

Continuing north of Middlesex Canal park, the canal, while overgrown on its banks, is a wide open clear waterway which ends at Route 95.

It is recommended that the canal prism be fully restored. Although the existing channel is wet and may pose permitting difficulties, the original canal prism is unrecognizable. Work to widen the canal would not require any filling operations and therefore may be easier to permit with local authorities.

In addition the bridge rails at the Middlesex Canal Park intersection should be repaired.

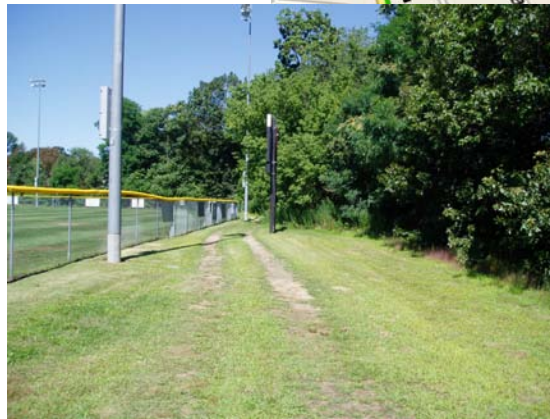
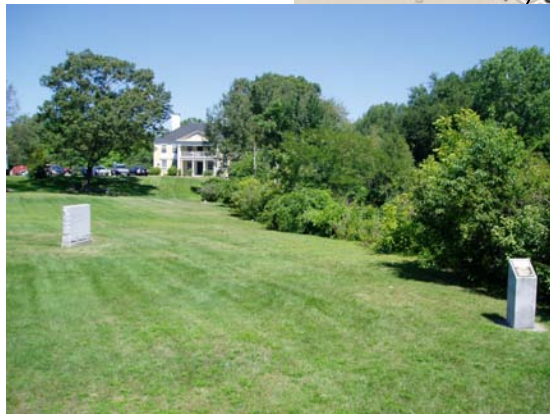
The southern terminus begins on the north side of Alfred Street with Kiwanis Park on the western bank and the “Sichuan Garden” Chinese restaurant (formerly the Baldwin Mansion) on the eastern bank. From this point, the canal winds its way approximately 2,560 feet to its northern terminus at School Street. The towpath is in good condition and exists the entire length along the easterly side of the canal. The abandoned RR bed exists parallel to the towpath at a slightly higher elevation

Along the western bank north of Kiwanis Park, the “1790 House” sits closely to the waterway. After the “1790 House”, the western bank is heavily wooded all the way to School Street. However, a narrow path exists through the woods which traverses through private property before opening up at Ferullo Field (City ball park).

It is recommended that the canal sides and embankments be fully restored. In addition, a paved bike path is recommended to loop around the canal segment utilizing the RR bed and the existing path location above the west bank. The existing towpath should be reconstructed as a Greenway.

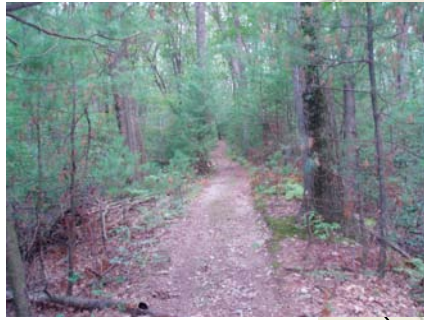
North of Butters Row the canal is also well defined. Unlike the previous section, the canal bed is wet and only the towpath is traversable to Patches Pond. The vegetation throughout this section is more dense consisting of scrub type plantings rather than the towering pines located on the southern dry section. At Patches Pond, the towpath ends at the intersection of four paths. Continuing northwest leads to private property. The northeast path followed along an ATV trail, and a southwesterly path ended at Towpath Drive.

The wet section north of Butters Row is not as well defined and the banks will need considerable work. Significant clearing would be required although the existing vegetation is mostly scrub and weed trees. Full restoration of the wet canal is recommended at Butters Row for a length of 100' and bank reconstruction is recommended to Patches Pond.

At the Maple Meadow Aqueduct, a pedestrian bridge will be required for access. It is recommended that the bridge utilize the existing abutments and be constructed to replicate the original aqueduct.

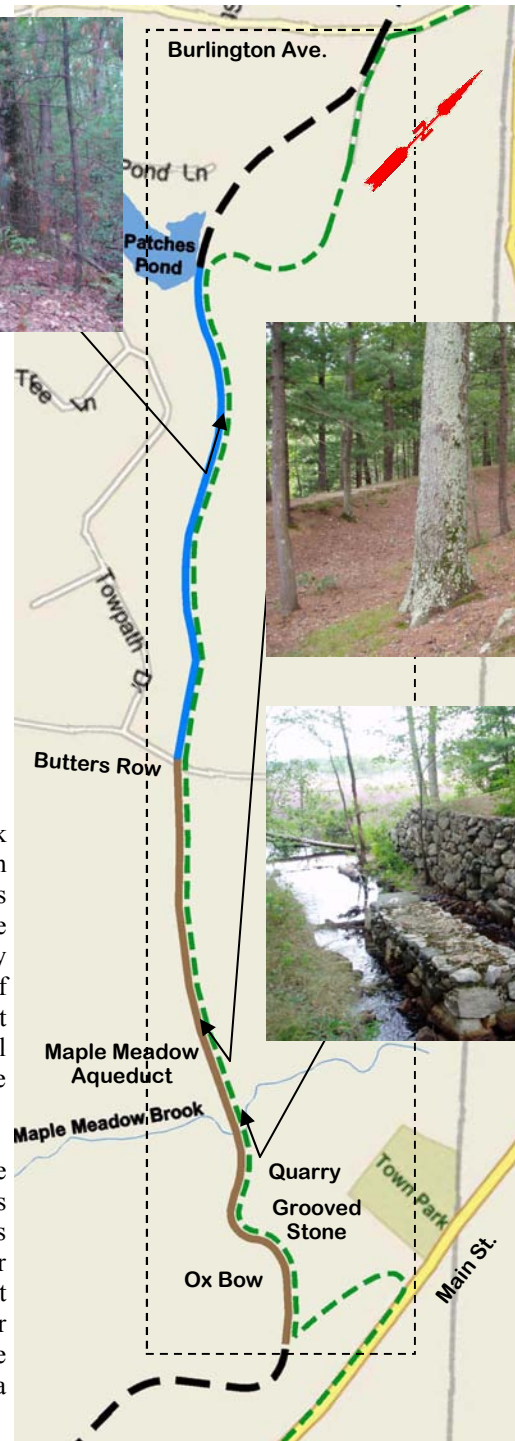
Access to this segments southern terminus is at the Town Park parking lot. Heading northwest along the canal route, the path rounds the Ox Bow, Grooved Stone, and Quarry national sites before reaching into the remains of the aqueduct over Maple Meadow Brook. Crossing the brook, there is approximately 2000 feet of well defined, dry canal remnants. This is one of the most dramatic sections of the existing canal prism as it allows visitors to see the impressive size and shape of the canal over significant length. Throughout this dry section, both the towpath and the canal bed can be traversed to Butters Row.

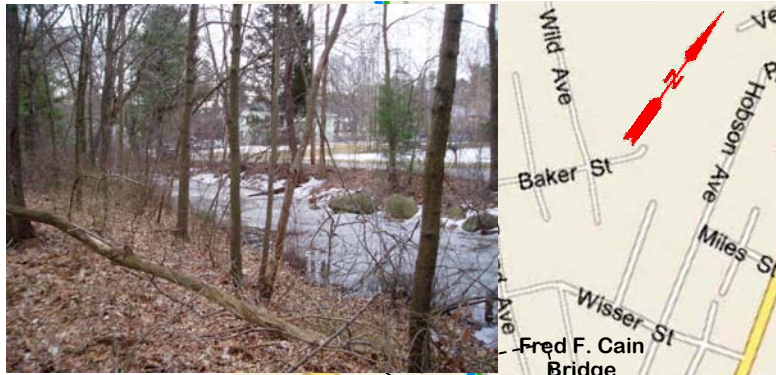
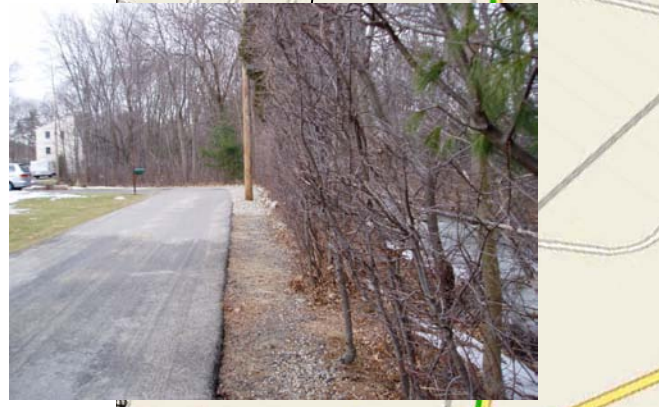
The section of canal beneath Richmond Street (Rt. 129) has been fenced off. Access can only be gained through a break in the fence along the commuter rail ROW. Beginning at this point and heading north, an inaccurate restoration effort was undertaken by the Massachusetts Highway Department in the 1980's. Since that time, the section of this restoration beneath Rt. 129 has become heavily littered and covered with graffiti. The previously mentioned fencing was likely installed to keep out this type of activity.

It is recommended that the canal prism from Bridge Lane to Richmond Street, be cleared of any debris and that the canal banks be fully restored.

The existing fences prohibiting access should be removed and, if feasible, reset along the commuter rail ROW. New fences should be installed if the existing cannot be reused.

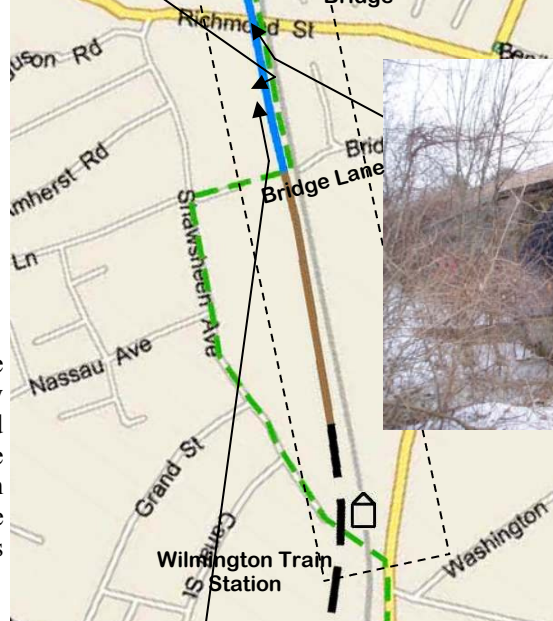
The canal is accessible at its intersection with Bridge Lane and from the northern terminus at Richmond Street. Only the portion of the canal from Bridge Lane to Richmond Street is easily identifiable as canal remains. Most of the prism from Shawsheen Avenue to Bridge Lane has been built over or filled in. From Richmond Street to Bridge Lane the canal bed is wet and paths (both sides of canal in this section) are both overgrown with trees and vegetation.

It should be noted that the previous restoration fell into disrepair. "Lesson learned" meetings should be held with local authorities and the Massachusetts Highway Department to help prevent any new restoration from sharing the same fate.

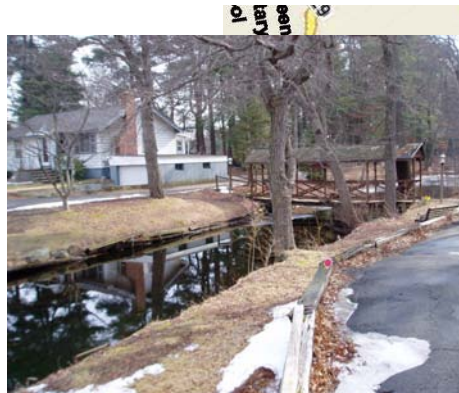
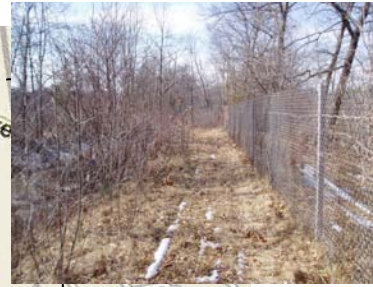
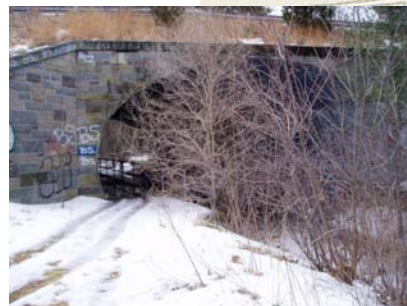
From the northern terminus at Lake Street, there is a clear view of the canal cross section, although it is located on private properties.

It is recommended that the canal prism be completely cleared of any debris. It is further recommended that the canal embankments be fully restored to the greatest extent possible with the understanding that rights to several private properties will be necessary for full length construction. Creation of a continuous path along the canal segment will require the construction of a crossing at Lubber's Brook.

An area of concern that would need to be addressed in this segment is the condition of the culvert at Richmond Street. The graffiti and refuse in that location create a concern for safety. It is recommended that the area be completely cleared of any debris and graffiti, and security features be added such as lighting and/or cameras.

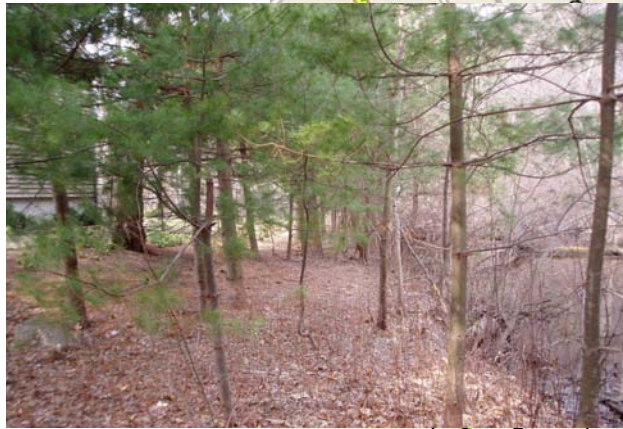
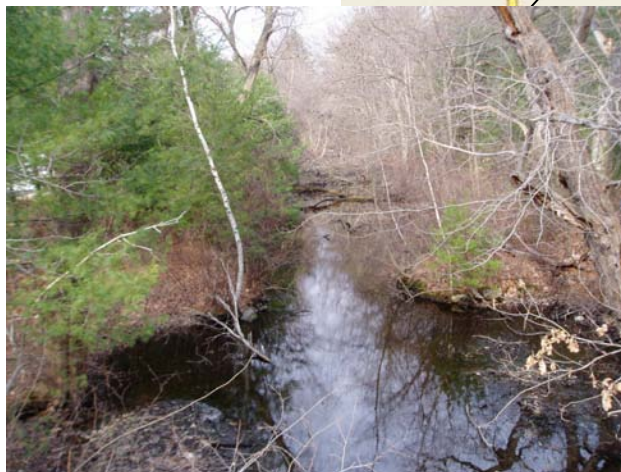
This segment is visible at both the northern and southern terminus. Fallen trees are littered along the pathways and over the waterway throughout this segment. The towpath is on the west side of the canal, but only the east side path can be traversed. Walking along the path, the topography becomes uneven at times and with heavy growth of vegetation. The canal bed is wet for the majority of the segment before gradually drying up and filled in as it approaches Nichols Street.

It is recommended that the canal prism be cleared of any debris and overgrowth. Also, the canal sides and embankments should be fully restored. The towpath can be restored on the west side, but the main walking path may need to be constructed on the east side of the canal as this is where cooperation with private land owners is likely to occur.

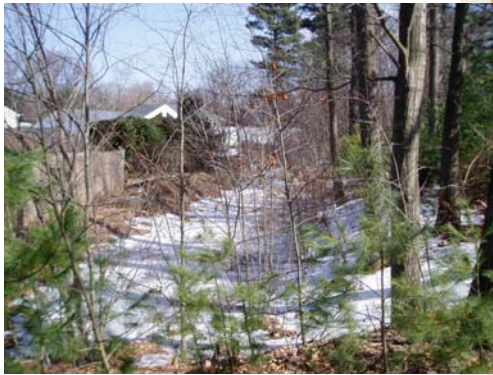
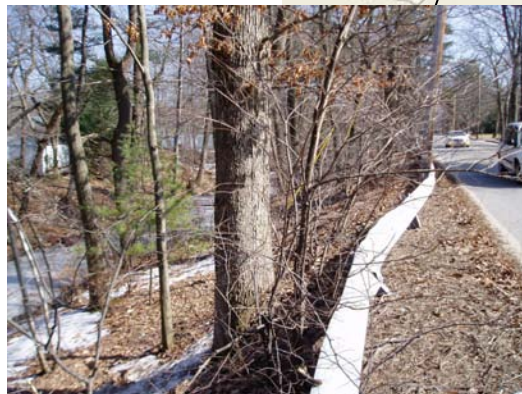
The entire length of this segment is visible from Shawsheen Avenue. Due to the overgrowth along the sides of the canal, the visibility is more apparent at Grace Drive and Melody Lane where the cross section of the canal can be recognized. The canal is wet with not much overgrowth in the bed, but more along the sides. The overgrowth continues into the towpath, which is on the west side, making it difficult to traverse in some sections.

It is recommended that the banks and towpath of the entire segment be restored. As this segment is located at the back of private property, acquiring access/maintenance easements may be challenging.

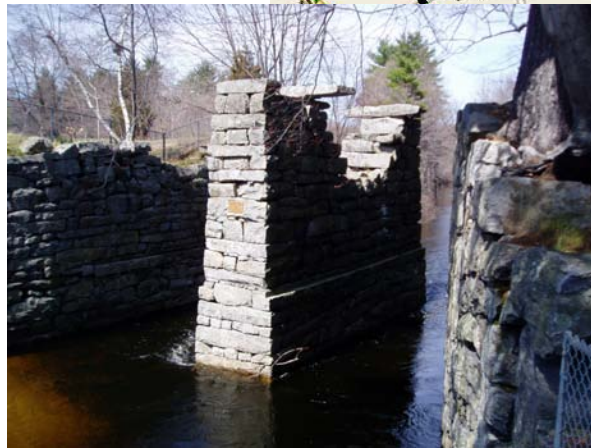
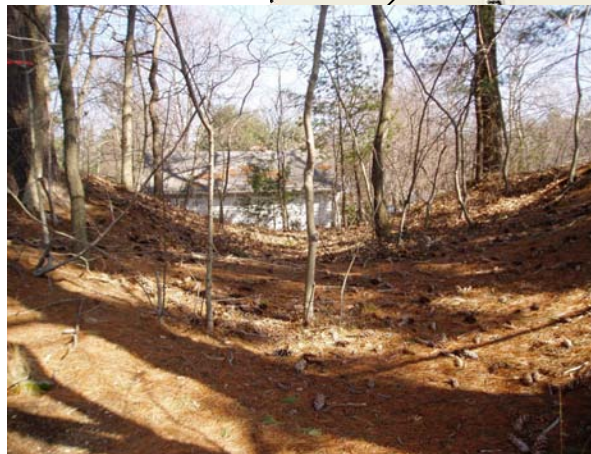
While the aqueduct is highly visible from Shawsheen Avenue the adjacent canal section is not. While access to view the aqueduct is available directly off of Shawsheen Avenue, access to the canal prism is not as simple. To reach the canal there is a path located on Town owned land at the end of Grace Drive. At this location the path leads south along the Shawsheen River and into a steep slope at the historic structure with the aqueduct and canal remains sitting about 10 to 15 feet higher than the pathway. There is some overgrowth in the canal segment with large diameter trees growing in the canal and on the towpath.

It is recommended that the canal prism and towpath be restored to its original geometry. In addition a great opportunity exists to create a public recreation space at the site. The existing pathway to the canal off of Grace Drive is owned by the Town of Wilmington. Through coordination with the Town, a public space could be planned at the site with the canal as the focal point. As several kayakers were observed using the site for access to Shawsheen River at this location, incorporating a canoe/kayak launch in to the site could become a very popular feature.

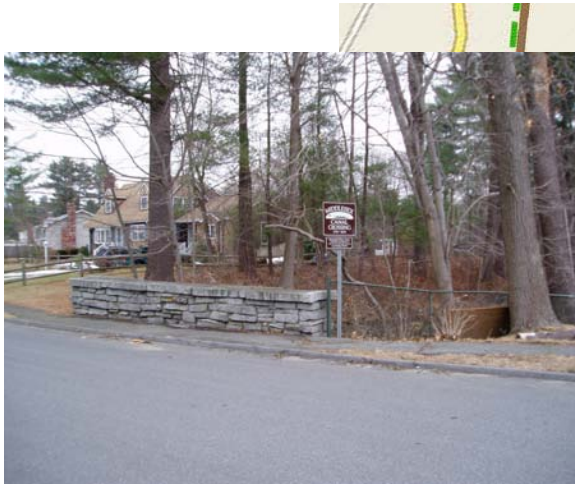
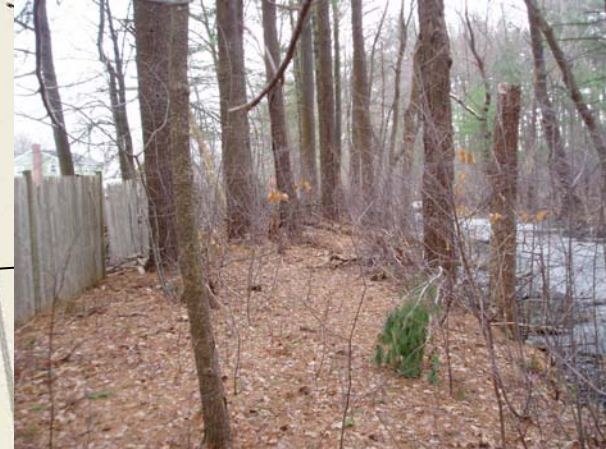
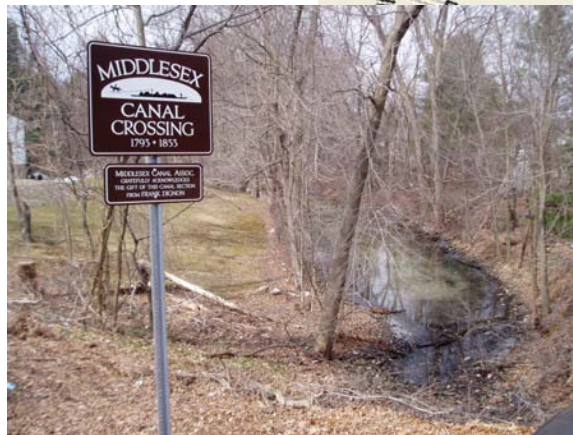
The canal segment is visible from both George Brown Street and Dignon Road. Tucked in a residential neighborhood, abutters' properties seem to be very close to the pathways of the canal. A bridge and culvert are located at Dignon Street and appear to be in good condition. The canal bed is wet and the embankments and towpath are overgrown. The existing paths are difficult to traverse due to the vegetation and uneven topography. At George Brown Street, there seemed to be little or no water flow and no culverts were observed.

It is recommended that the canal embankments be completely restored. The original cross section of the canal can be recreated without significant disruption. A Greenway should be constructed at the location of the existing towpath, which is on the west side of the canal. The canal at this location appears to be used as a drainage channel although positive flow could not be determined. An inspection of local culverts and their condition should be performed.

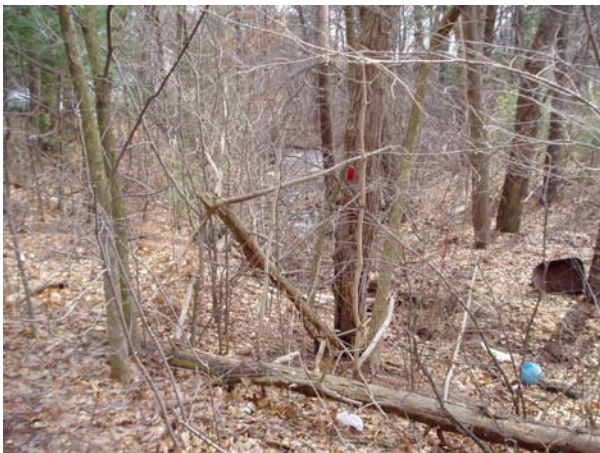
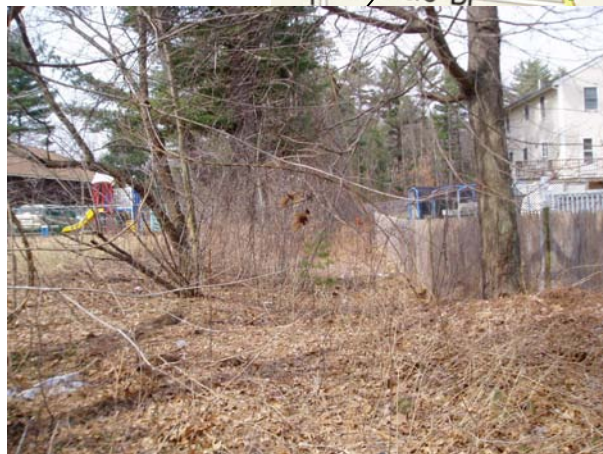
This segment of the canal is not visible from a major roadway. After a short walk into the woods from Kitchen Ave, the canal cross section becomes evident. The canal is a mixture of dry and wet areas with uneven topography throughout the segment. The sides of the canal retain some form, but are overgrown with trees and other vegetation. The growth continues into the towpath, which is on the west side of the canal. The segment ends at Staples Street, which was built over the canal prism. At this location the canal way is well below the elevation of the roadway.

It is recommended that the canal prism be fully restored. The original cross section of the canal can be recreated without significant disruption. A Greenway should be constructed for easier access through the canal segment and to highlight the

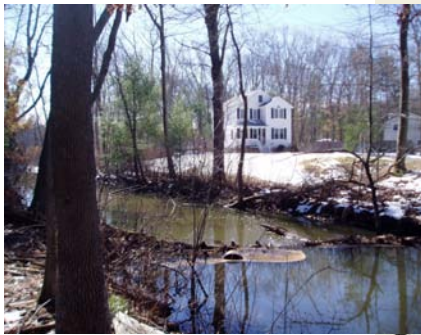
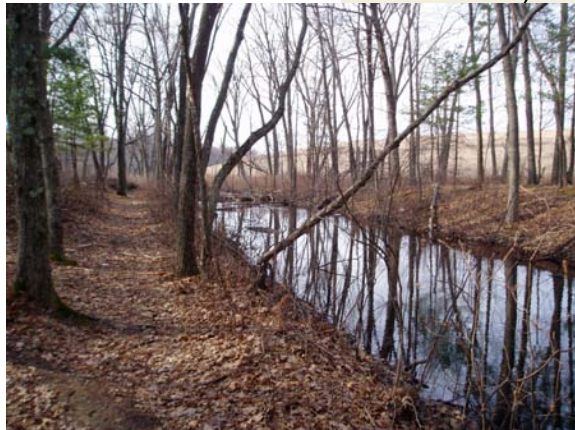
The segment begins in the wooded area behind the properties of Kara Lane and to the west of overhead power lines. The canal bed to the south is dry and a walking path exists on the east side. Before the canal becomes wet, approximately 800' into the segment, the path crosses to the west which is the location of the towpath. The elevation of the path soon dips, exposing numerous tree roots. In addition overgrown conditions exist along the canal sides including trees and other vegetation. Approximately one half of the way through the segment the towpath drops below the water level making it impossible to traverse.

From Pond Street, there is a clear view of the canal cross section. A path can be traversed for a short length along the east side of the canal before it drops below the water again. No continuous pathway exists along the entire length of this segment.

It is recommended that the canal prism be fully restored along the dry section of the canal segment. For the wet section, the embankments and towpath should be restored. The towpath would need to be built up to cover the tree roots for a safer passage. The towpath would also need to be raised to provide a continuous Greenway although the environmental impacts of filling a wet area may be limiting.

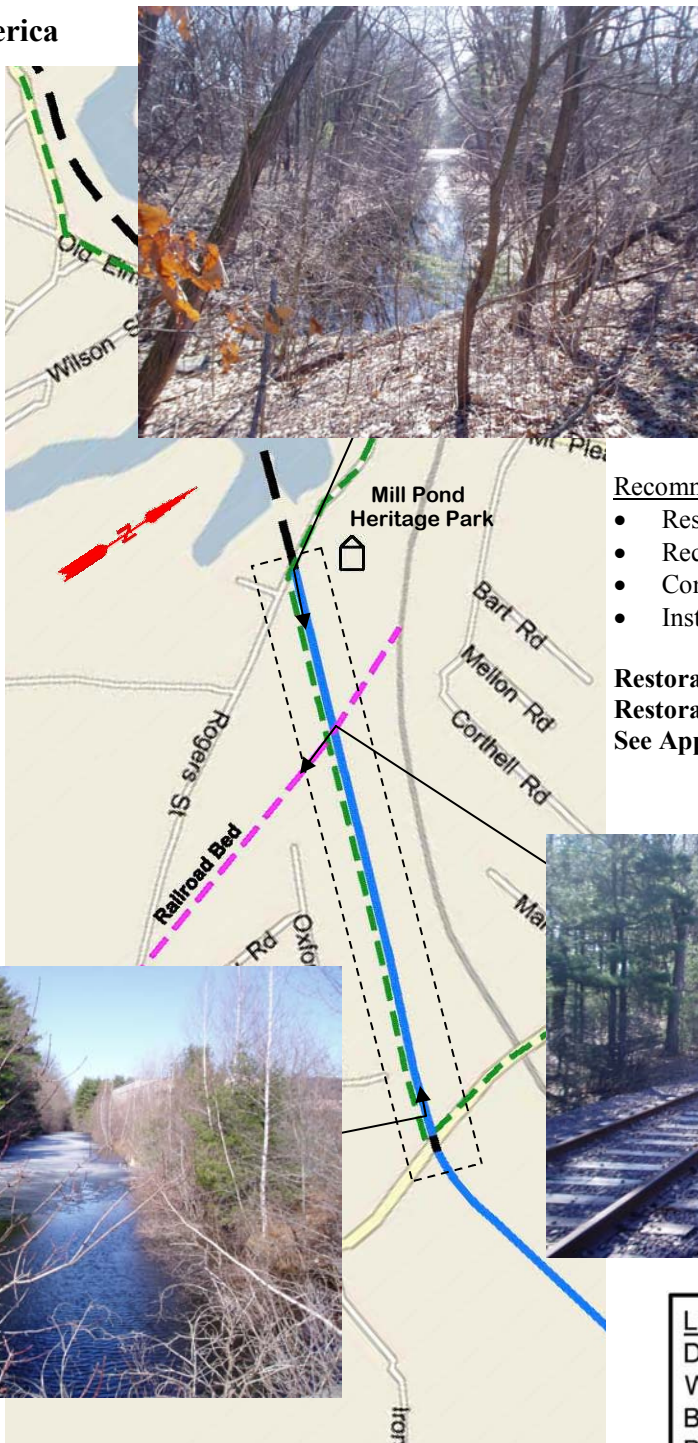
This segment is visible from both the northern and southern terminus. From the north at Rogers Street, there is a steep slope on the west side of the canal leading down to the towpath. The towpath and canal are bisected by an RR track approximately 700 feet to the south before continuing on to High Street.

The canal way is at a consistent water level for the entire segment and the towpaths are intact with just some uneven topography. Some overgrown conditions occur in the towpath and canal way which include trees and other vegetation. From the southern terminus at High Street, there is an access way for pedestrians with a stone marker on display indicating the presence of the canal.

It is recommended that the canal embankments be fully restored and the towpath be reconstructed as a Greenway. Providing a continuous path throughout this segment will be dependent upon providing an acceptable crossing at the observed RR track.

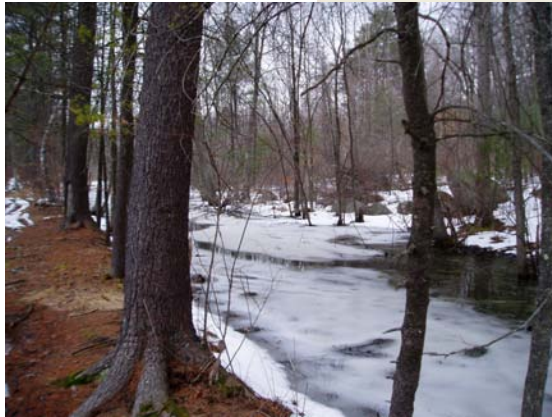
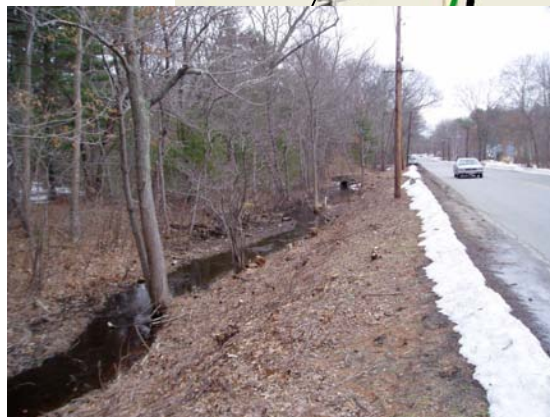
The northern section spans from Boston Road to Brick Kiln Road and is not as visible from the roadway. Here, most of the canal has wet with standing water. The canal prism was difficult to identify at several areas throughout this section.

It is recommended that the canal prism be fully restored from the fire station to Boston Road. It is also recommended that the canal embankments be restored from Boston Road to Brick Kiln Road. It is noted that the restoration effort at several area of this section will require significant filling of wetland in order to construct a proper canal bank.

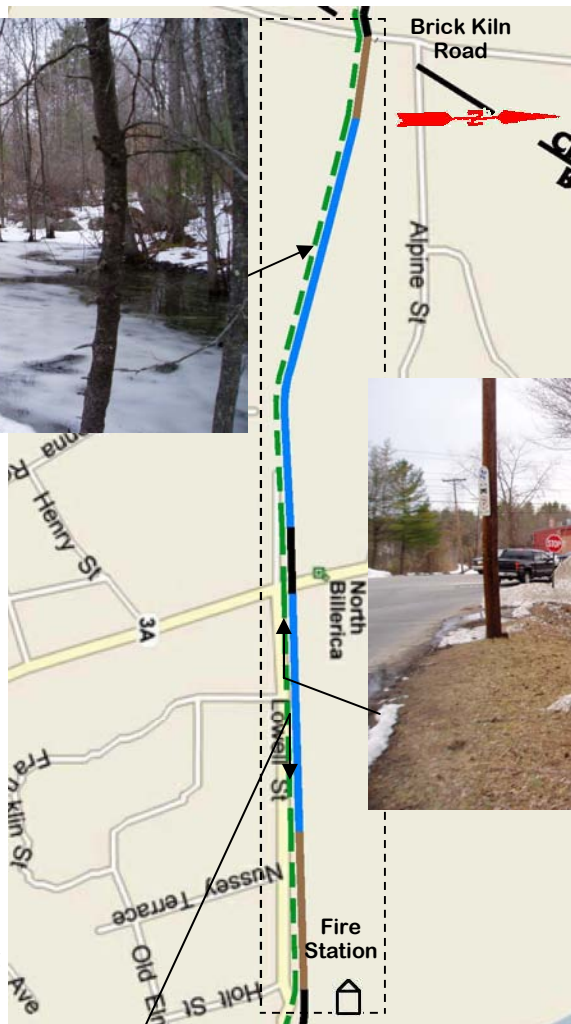
This segment consists of two sections with varying conditions. The southern section, traverses from the fire station to Boston Road and is fully visible from Lowell Street. The western bank of this section has been recently cleared of brush and trees, but the east side still overgrown. Four culverts were observed with water flowing in the entire section. Approximately half of this section is wet.

This segment presents ample opportunity to restore the canal and provide public interest. The high visibility from Lowell Street adds to the importance of this location as a key site on the canal trail for education of the public and awareness of the canal's history.

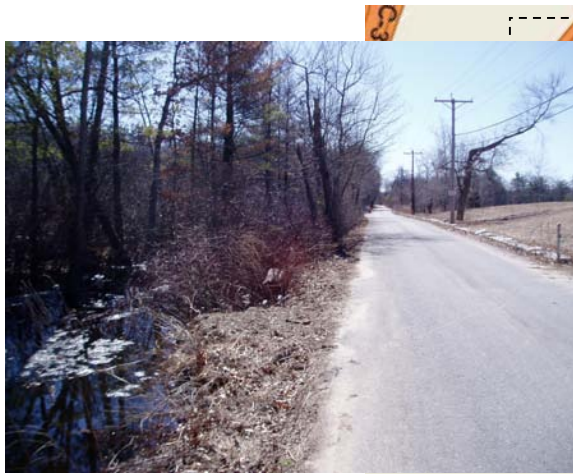
There is an overgrowth of trees and other vegetation for the entire length of the segment in the canal bed and along the sides.

A raise in the road grade will be necessary at the southern end of the segment to prevent the canal from flooding Canal Street.

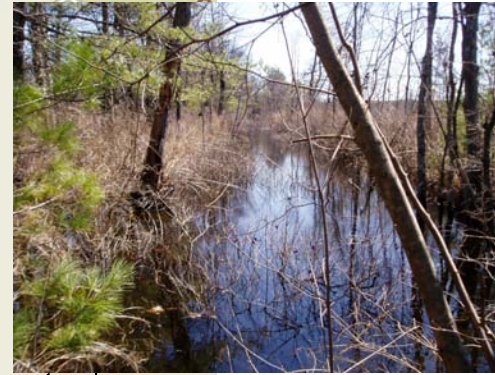
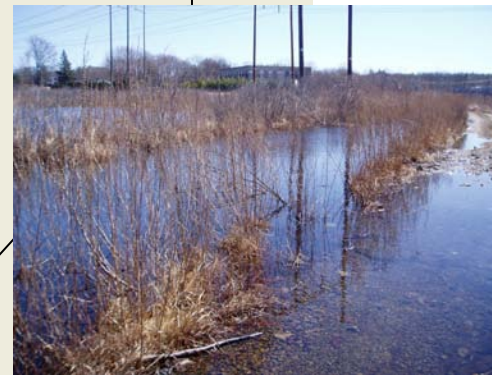
Beginning at the northern end of this segment at Riverneck Road and traveling south, the towpath for this entire canal segment has transformed into a 20 foot wide road. Heading south along Canal Street the water way is visible on the left and continues is wet for approximately 1,000 feet to the site of an abandoned house. The water level is high with not much of an embankment showing on either side. After an abandoned house, the canal bed continues dry for about 1,500 feet and then becomes wet again. Approximately 800' north of Brick Kiln Road, the canal banks spill over onto Canal Road and floods the area. It is here where a large water body exists with hydraulic continuity to the canal. During wet seasons it is assumed that this flooding condition regularly exists. From this point south, the area has been developed with commercial buildings and the canal prism is unrecognizable.

It is recommended that the canal embankments be fully restored in all the wet areas of the segment and the entire canal prism be restored at dry locations. Construction of a Greenway at the towpath location will be a challenge as the towpath has been consumed by Canal Street. It is recommended that the shoulder of the street be widened to create a roadside path wide enough for safe passage of pedestrians and cyclists.

- Restoration of embankments along wet canal sections
- Reconstruction of canal prism at dry locations
- Adjustment to grade of Canal Street to prevent flooding
- Installation of illustrative signage

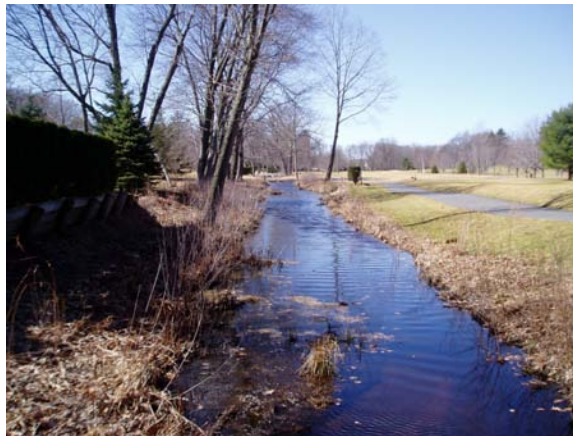
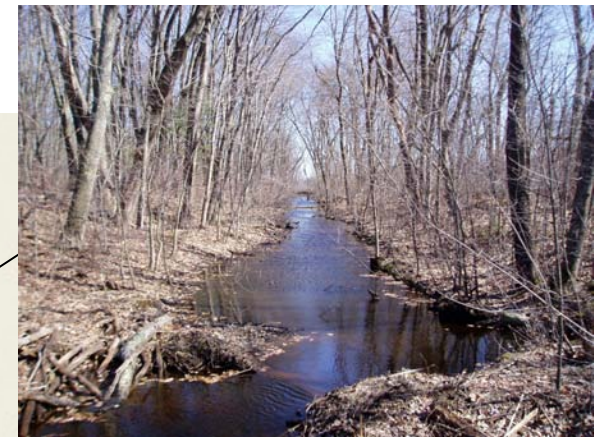
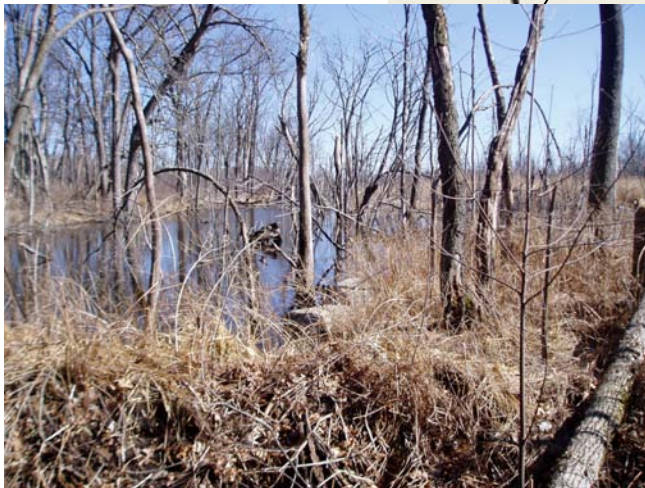
Access could not be gained from the southern terminus due to the thick brush and wetlands. Entering from the golf course was much more feasible. The canal through the golf course is well defined and maintained. Heading south at the limit of the golf course property, the canal could be traveled along for approximately 500 feet before wetlands obstructed the path. The canal bed and towpath had overgrowth conditions with trees, vegetation and some uneven topography. The water was at a consistent level.
