# Assessment of Effects Memorandum, Middlesex Canal Historic and Archaeological District

Iron Horse Park Superfund Site, Operable Unit 3, Area of Concern 1

30 October 2020

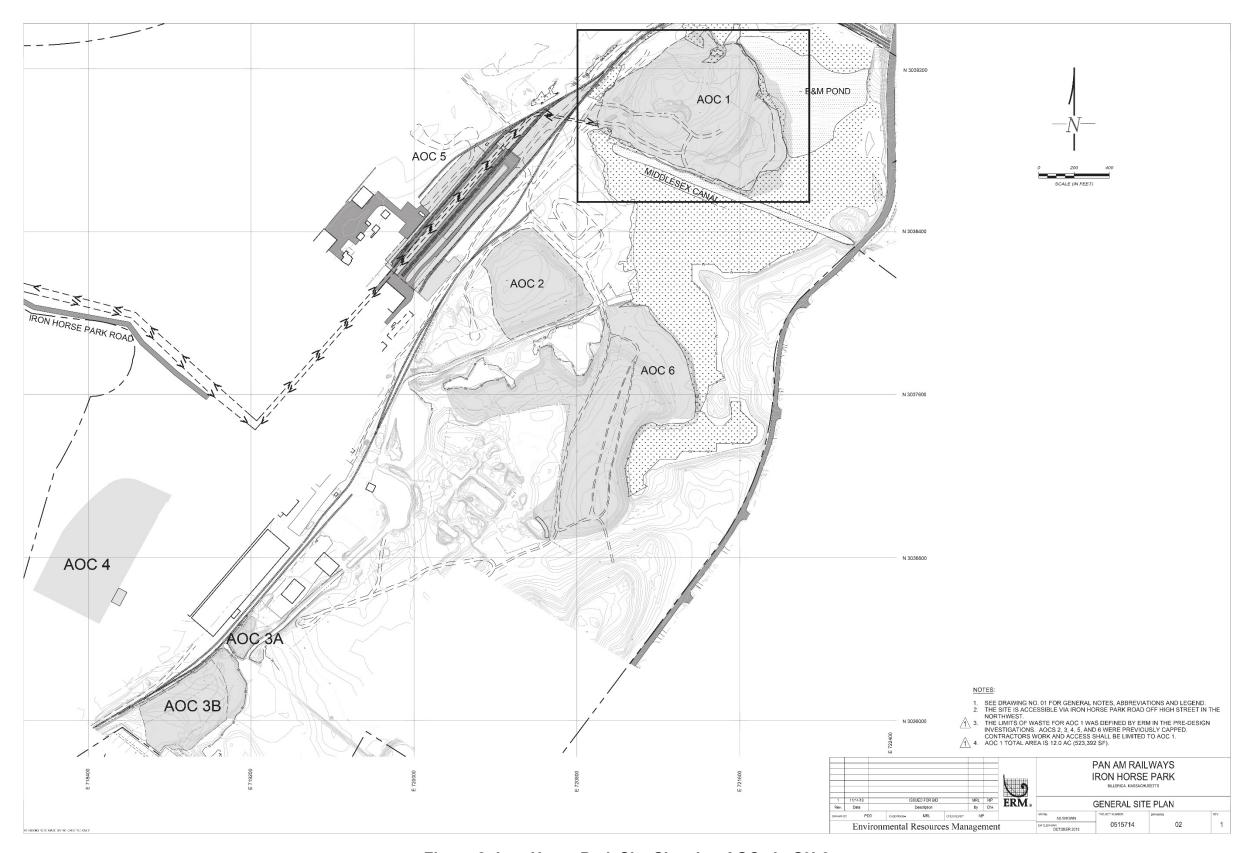
Figure 2: Iron Horse Park Site Showing AOCs in OU-3

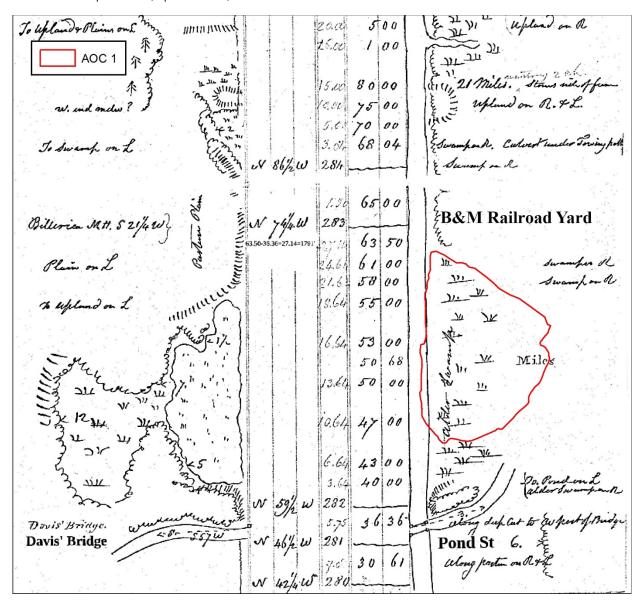
Figure 4: Field Survey Showing Middlesex Canal in 1829 in the Vicinity of AOC 1

A plan of the canal made in 1829 and notes from a survey book show the geography in this area after the construction of the canal (Baldwin 1829a, 1829b). The survey book map (Figure 4) shows a heading and distance (N 59 ½ W, 27.15 rods [1,792 feet]) from Pond Street to the B&M Railroad Yard that encompasses the survey area. In this view, the south side of the canal is on the left and the north side on

the right. The numbers in the center to the left of the canal show the heading and distance, the sequential number of headings, the number of chains (equal to 66 feet) from the last point recorded, and the cumulative number of chains from the beginning of the spread. The survey for the section near AOC 1 shows hachure marks on the east and west ends on the north side of the canal that indicate high ground, while most of the 1,791-foot section bordered a swamp. Most of the area on the south of the canal was labeled "alder swamp." The towpath and berm that held in the water of the canal are not shown, but would have been necessary in this area to separate the canal from the low areas. The plan map (Figure 5) shows a similar swampy area on both sides of the canal at AOC 1 between Pond Street and a bend in the canal that was covered by the construction of the B&M Railroad Yard in 1913.

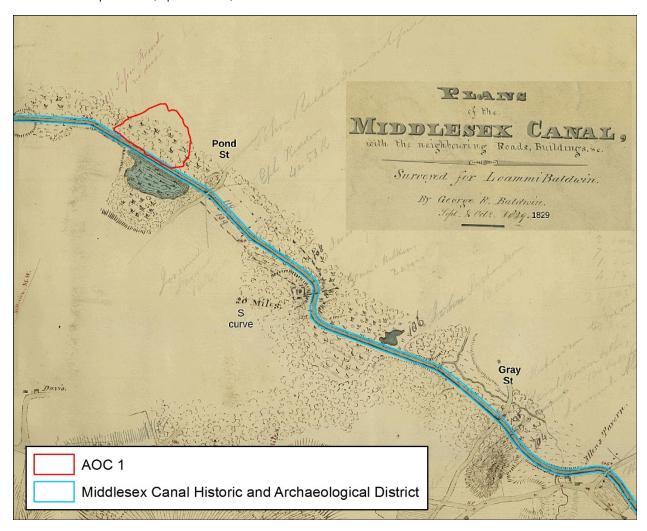
Figure 5: Plan of the Middlesex Canal in 1829 in the Vicinity of AOC 1

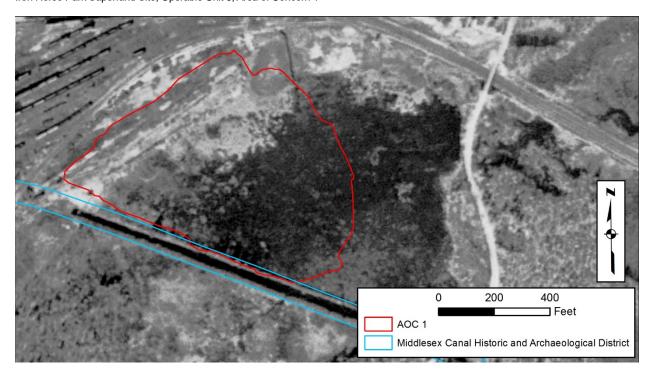
Figure 7: Aerial Photograph of the Vicinity of AOC 1 in 1938

The Iron Horse Park Railroad Yard was constructed in 1913, and the canal to the west of AOC 1 was covered over by railroad sidings and shops. A series of aerial photographs (NETROnline 2020) shows that the banks of the canal between Pond Street and the railroad yard were well defined during the midtwentieth century, but as the wetlands on the north side of the canal were filled in with waste from the railroad yards, the boundary of the canal became less distinct. A 1938 aerial photograph shows that the eastern portion of AOC 1 was almost entirely wet at that time, and the towpath and berm are clearly defined (Figure 7). By 1971, fill from the railroad yard had pushed well into the western part of the wetlands and the line of the north bank of the canal had become more irregular (Figure 8). The southern bank containing the towpath remained straight, however, with a row of trees separating the canal from the wetlands to the south. By 1995, both banks of the canal had become irregular and less distinct from the adjacent lands.

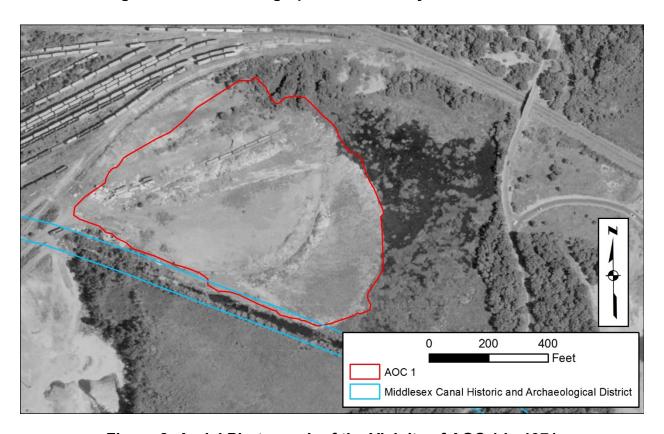
Figure 8: Aerial Photograph of the Vicinity of AOC 1 in 1971

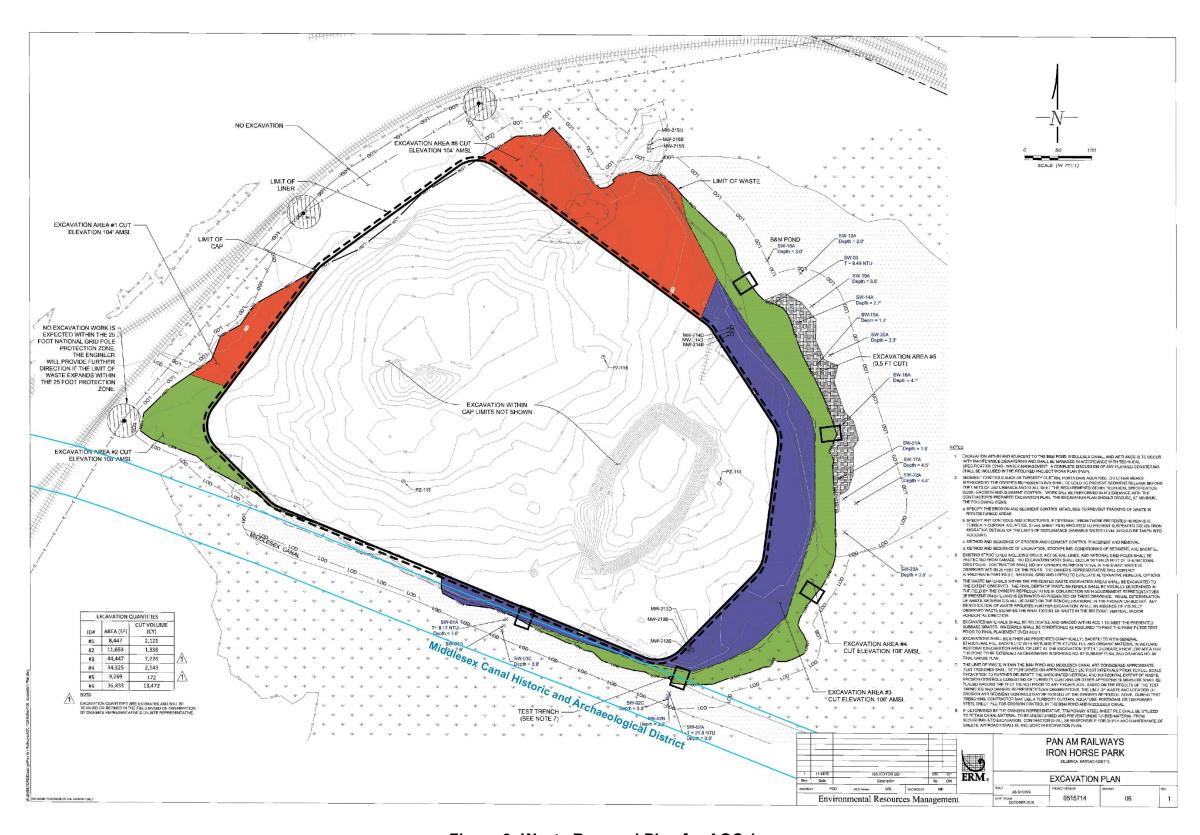
Figure 9: Waste Removal Plan for AOC 1

Figure 9 shows the waste removal plan proposed at AOC 1, while Figure 10 shows the final grading plan (ERM 2019). The remedy for AOC 1 is the excavation of wetland soils around the edges of the site and the placement of the excavated soils into the center of the landfill within the site. A geosynthetic liner will be placed along the margin of the landfill site to prevent leeching, and the excavated soils replaced with imported fill. The landfill will then be graded and capped, with the top of the fill being less than 135 feet AMSL. The surface of the graded landfill would be planted in cool season grass (ERM 2012).

Excavation Area #2, in the southwestern part of the site, extends in a narrow band along the northern bank of the far western end of the extant canal channel. The limit of waste does not encroach on either the historical or current canal limits and therefore the erosion controls for this excavation area will be limited to coir logs installed inboard of the canal. Once all waste has been removed and consolidated within the landfill, the excavation would be filled and graded. The top of the bank would be approximately 1 foot higher. From the top of the bank, or berm, the slope would continue uniformly and steeply toward the center of the landfill cap in AOC 1. This differs from the current slope, which levels somewhat, then slopes upward to 128 feet AMSL, compared to 133 feet.

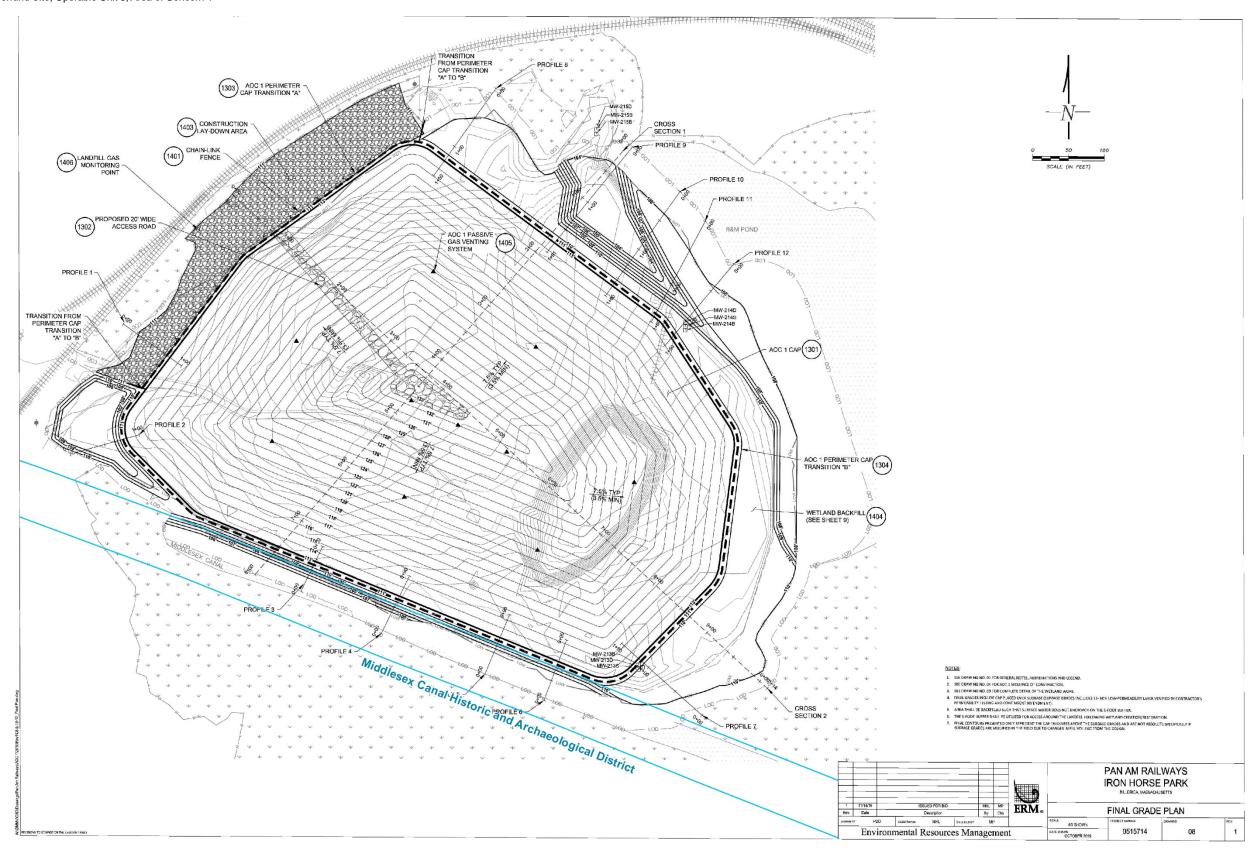
Figure 10: Grading Plan for AOC 1

Once complete, it is estimated that the excavation would extend approximately 10 feet into the canal channel. The excavated area would then be filled and graded, which would change the profile of the canal bank, creating a steeper rise that would be 1 foot higher than currently exists, and would slope more uniformly and steeply away from the bank and to a greater height. However, the current profile does not reflect the historical profile of the canal because of erosion of the berm and infilling of the wetlands behind the berm as part of the development of the B&M Railroad Yard during the twentieth century.
